# Wad Ben Naga Report V: The Palace of Amanishakhet

Vlastimil Vrtal

National Museum  
Prague 2024

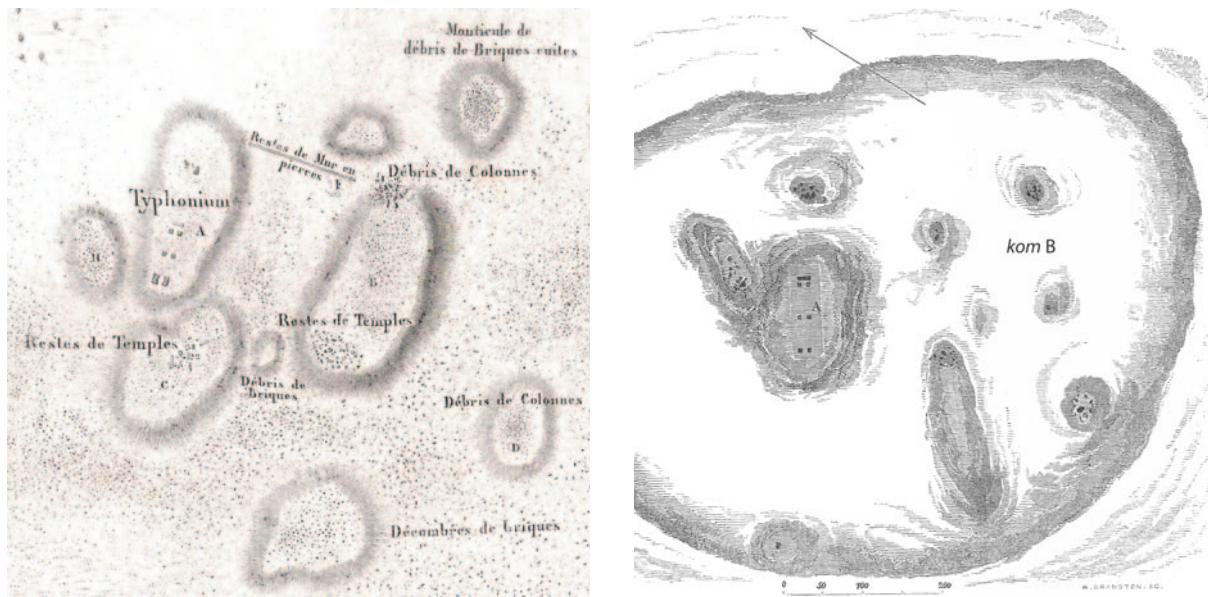
Fig. 1.1 Plan of the site of Wad Ben Naga published by Cailliaud in 1823 (left), showing kom B covering the remains of the Palace of Amanishakhete [Cailliaud 1823: I, pl. IX], and the same area on the plan of the site by Hoskins (right) with the approximate position of kom B [after Hoskins 1835: 114].

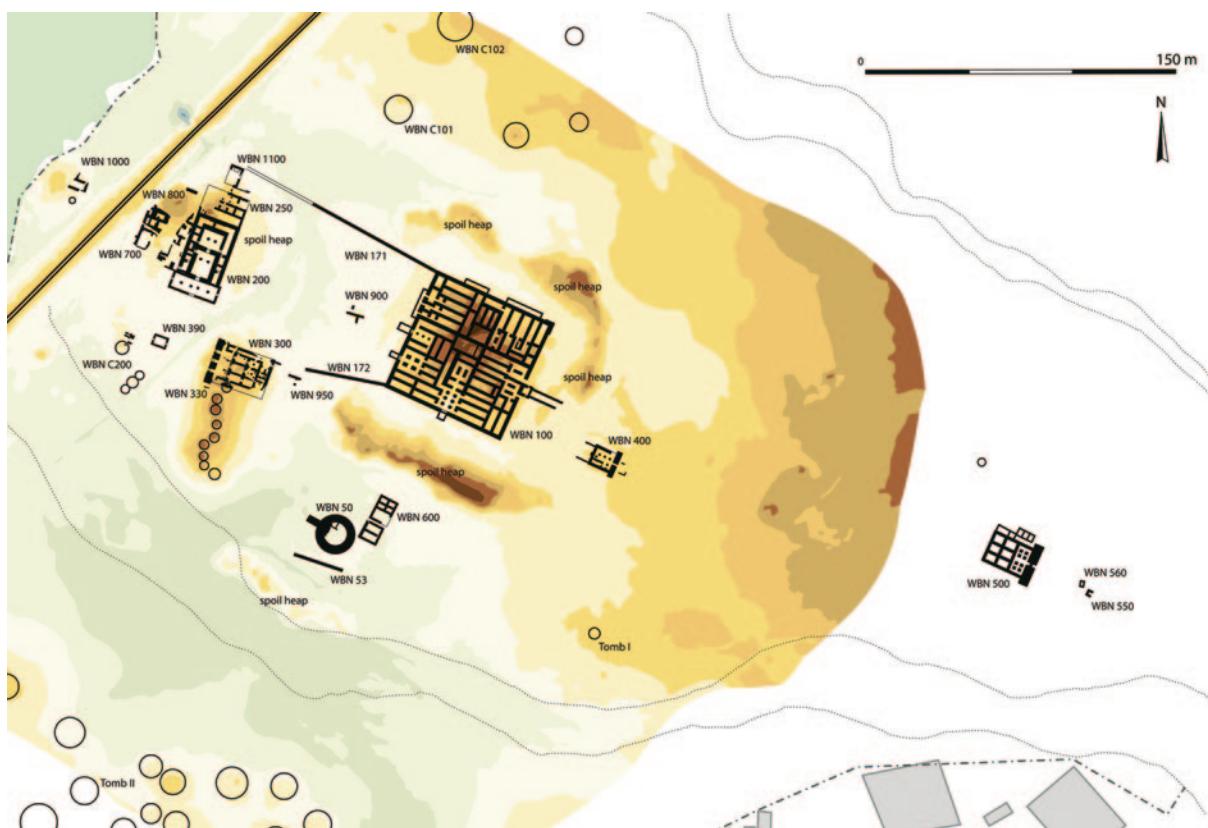
Fig. 1.2 The site of Wad Ben Naga in the present state of research with the Palace of Amanishakhete (WBN 100) in the centre.

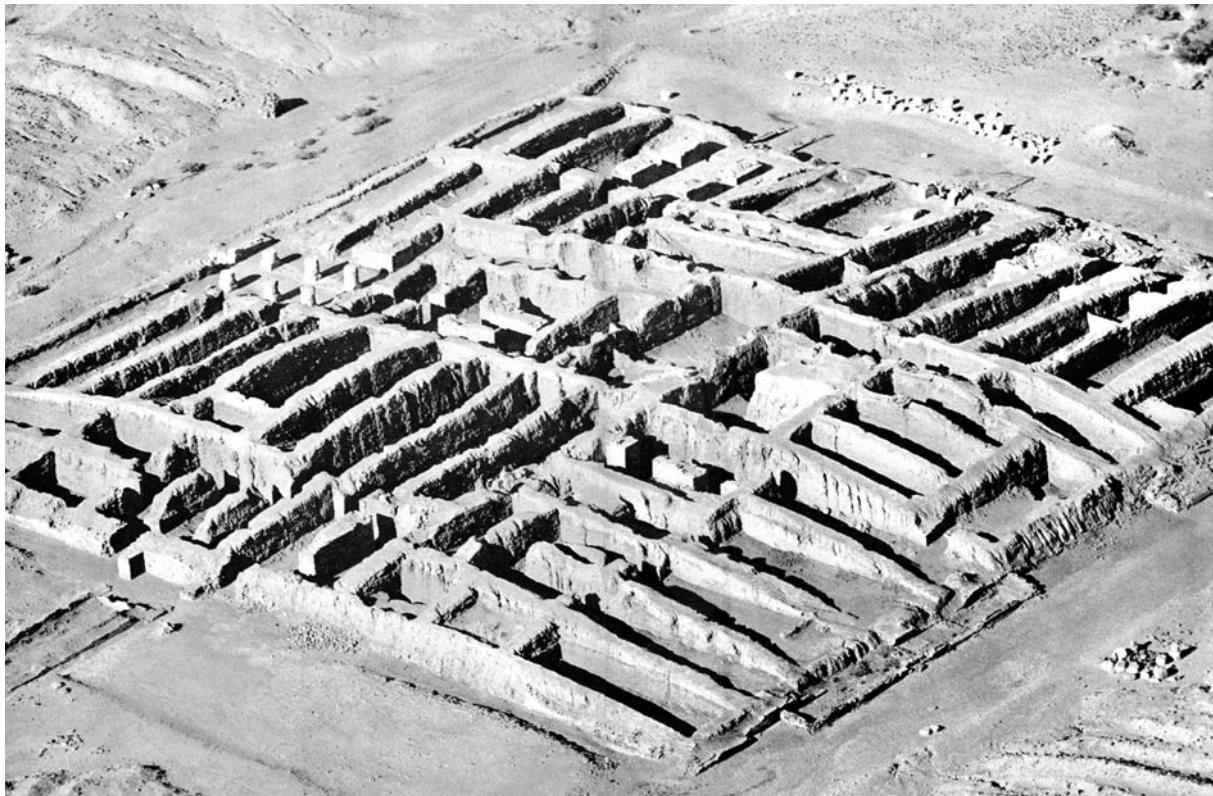
Fig. 1.3 The Palace of Amanishakhete on an aerial photograph published by Georg Gerster in 1964, four years after the termination of the first excavations [© Estate Georg Gerster, Switzerland, [www.GeorgGerster.com](http://www.GeorgGerster.com)].

a couple of publications on ancient Nubia.<sup>27</sup> These photographs are invaluable in that respect that they show the ruins of the palace in the state of preservation at the time of its unearthing or shortly after (fig. 1.3).

**SAS.025:** The photograph captures the second season at the end of excavations. Based on comparison with SAS.012, the feature captured on the photograph can be clearly identified as the entrance to room WBN 128. On the right, wall WBN 143/148 is rather only roughly cleared; mudbricks seem to predominate. An elongated vertical break in the wall is apparent close to the entrance, probably caused by erosion. Two bricks, possibly fired, protrude from the face of the wall; they do not seem to be *in situ*. Wall WBN 128/143 is made of mudbrick with fired brick door jamb only.<sup>23</sup> In the upper part, the door jamb recedes by ca 20 cm and continues upwards, likely in fired bricks. This step reminds strongly of a similar step in room WBN 119 that can be noted on photographs SAS.031–032. At the same height as the step, a wooden lintel seems to be laid horizontally, resting on the step in the wall and in wall WBN 143/148. On the lintel, either a wall or brick debris can be noted, with at least two rows of bricks sloping towards the north. The space representing the entrance to room WBN 128 is filled with brick debris (the lower part) and mud deposited in thin layers (the upper part). Remains of a nearly fully disintegrated wooden threshold can be noted at the floor level, corresponding to the pocket in the door jambs that was to accommodate it. At about a half of the height, a different structure in the section can represent either another piece of wood or mud layers. Two curious circular features can be clearly noted just under the lintel. It is hard to tell their nature from the photograph, but given their shape, they might represent negative imprints of wooden posts. The section remained unexcavated, as apparent from a later aerial photograph (fig. 1.3).<sup>24</sup>

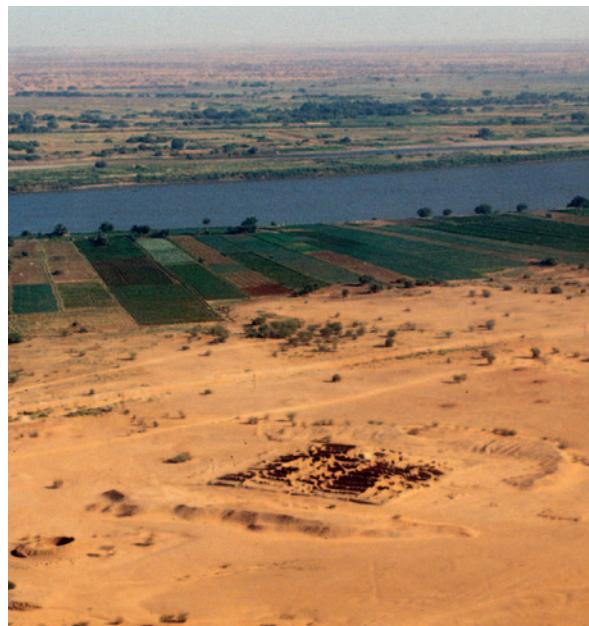
Fig. 1.4 The Palace of Amanishakhete on an aerial photograph (cropped) captured by Friedrich W. Hinkel in 1999 [© Deutsches Archäologisches Institut Berlin, Archiv der Zentrale, Archiv Friedrich W. Hinkel].

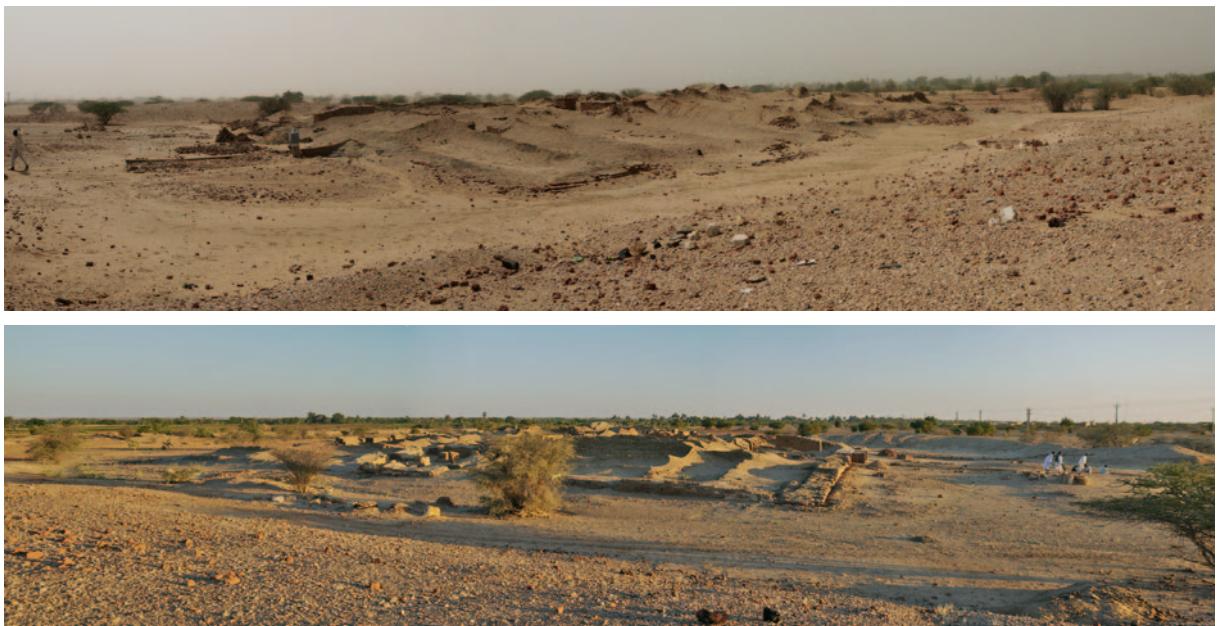
Fig. 1.5 The remains of the Palace of Amanishakhet  
as seen from the northern (top)  
and southern spoil heaps (bottom).

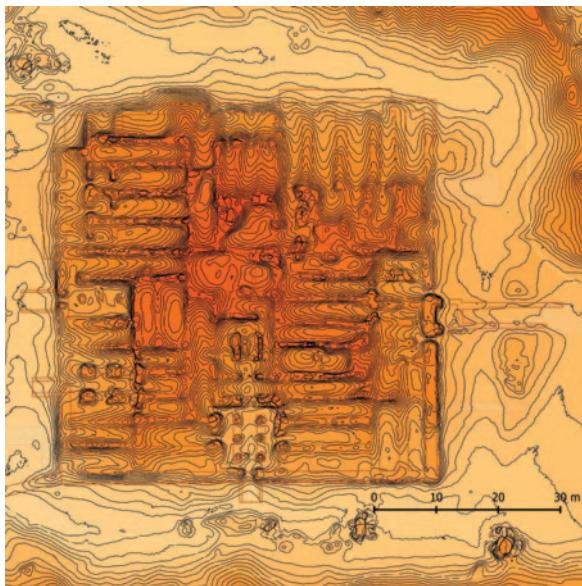
Fig. 1.6 Elevation model of the remains of the Palace of Amanishakhete in the current state of preservation; isohyps at the interval of 0.1 m.

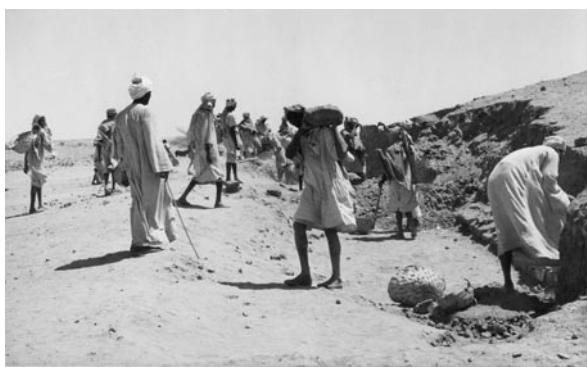
SAS.005

**SAS.005:** The photograph captures the first season of excavations; clearing of the exterior wall is captured. In the background, hills to the east of the present village are captured, which is in concordance with the position of shadows; the northern exterior wall is thus being cleared, likely in the vicinity of the north-western corner. In the foreground, the wall seems to be formed of fired bricks laid on their edges, representing the foundations of the wall. In trench T20, the northern exterior wall was indeed preserved only to this height.<sup>13</sup> The surrounding soil seems to be formed of brick debris to a considerable extent. Seventeen workmen and the *rais* are captured.

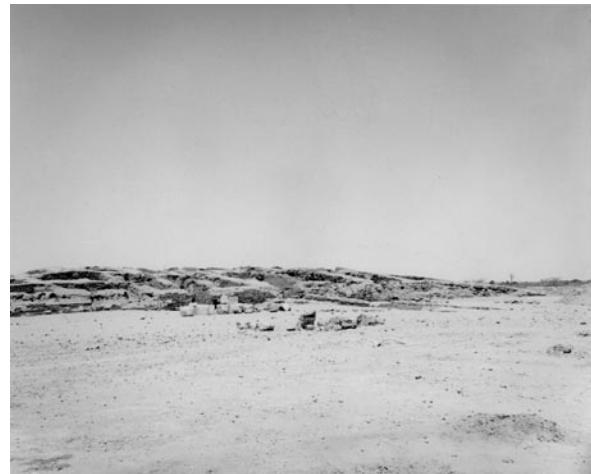
SAS.011

**SAS.011:** The photograph captures the second season at the end of excavations. The palace is viewed from the east. Almost whole length of the eastern exterior wall is captured. In the foreground, fragments of the larger-than-life-size statue of Sebiumeker are scattered; behind, column drums are deposited in a row. To the left of the column drums, torus moulding can be noted on the façade. On the right side, remains of exterior ramp WBN 161–162 are well-visible.

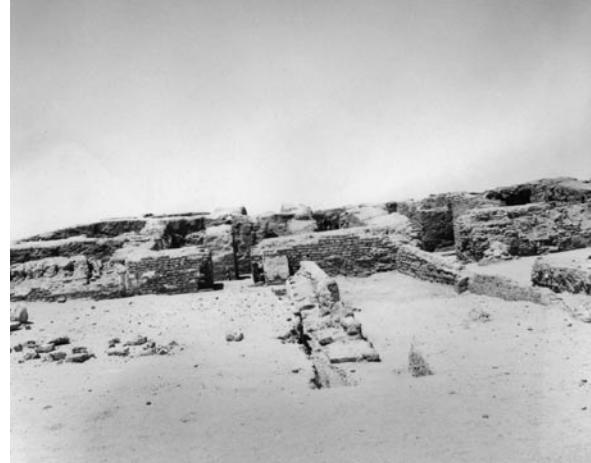
SAS.013

**SAS.013:** The photograph captures the second season at the end of excavations. The palace is viewed from the east. Rooms WBN 141–143 are captured. Torus moulding is well-visible on the façade on the left. Nearly complete remains of exterior ramp WBN 161–162 are captured in the foreground, part of the northern wing is missing. Transition in the thickness of the walls of the ramp can be noted on both wings.

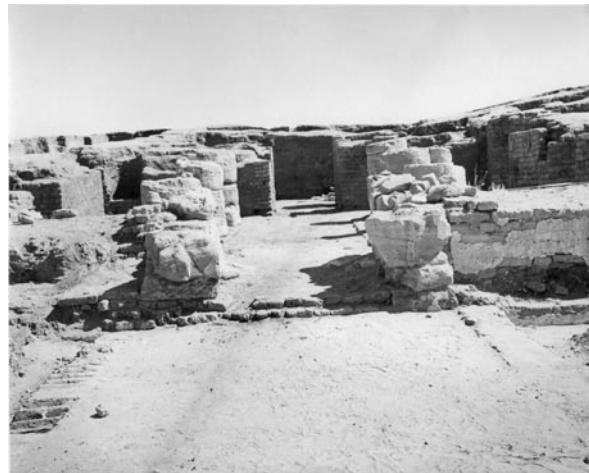
SAS.019

**SAS.019:** The photograph captures the second season at the end of excavations. In the foreground, foundations of ramp WBN 163 are visible, with bricks laid as inclined rowlocks. In the centre, room WBN 154 can be identified, with its sandstone door jambs and three pairs of sandstone columns. The threshold, now lost, is partly made of fired bricks. Entrances to rooms WBN 111 and WBN 157 are clearly defined on the left. In the rear, the northern wall of room WBN 156 is visible, as well as a brick laid on the floor in the north-eastern corner of the room and captured in detail on photographs SAS.038–039. The upper sections of walls of room WBN 157 are well-visible, showing no remnants of the ramp mentioned by Vercoutter.<sup>20</sup> Unlike in Hinkel's plan, only small parts of it seem to be made with fired brick casing. A pounder rests on the western column of the southernmost pair of columns. A footed (?) shallow bowl or lid is deposited on the eastern one, together with two other sherd.

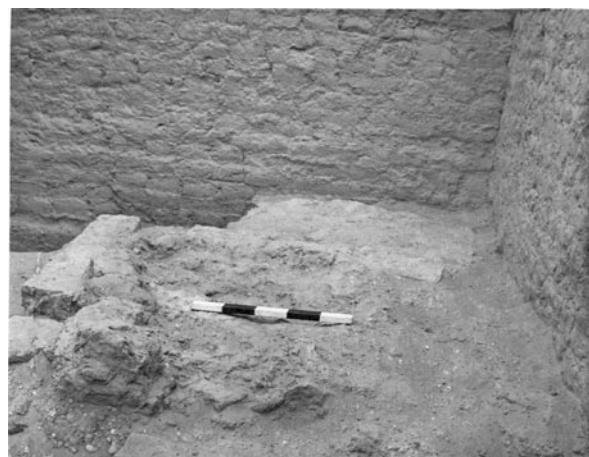
SAS.037

**SAS.037:** The photograph captures the second season at the end of excavations. The room captured cannot be identified. Surrounding walls are made of mudbricks, and the room should thus be sought in the interior. Given the state of preservation, the photograph must come from the palace. The feature photographed is an irregular debris framed on two sides by perpendicular lines of brickwork (one or two courses maximum) or sandstone lintels. In the lower left corner, a layer of pebbles reminiscent of the material used as the fill elevating floors can be noted.

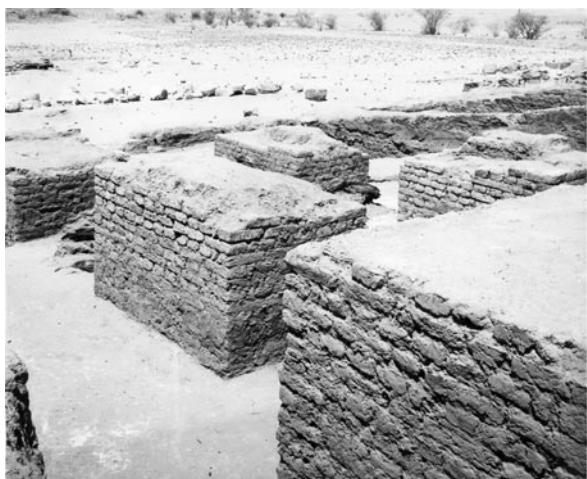
SAS.054

**SAS.054:** The photograph captures a scene similar to photograph SAS.053. In the foreground, the entrance to room WBN 112 can be seen. In the centre, room WBN 103 is visible, with four pillars and burnt wooden beams by the north-western and south-western pillars. Plaster can be noted on some of the pillars and on the northern wall of the room.

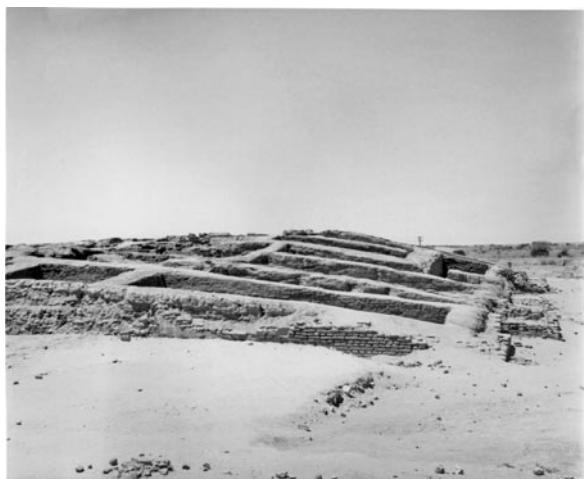
SAS.067

**SAS.067:** The photograph captures the second season at the end of excavations. The north-eastern corner of the palace is captured, viewed towards the west. In the foreground, the debris from the exterior wall, excavated in trench T55,<sup>61</sup> can be seen left *in situ*. The fortified corner of the exterior wall can be noted. Further to the west, podium structure WBN 167E abuts the northern exterior wall or possibly it is bound with it. The podium structure consists of outer light walls made of fired bricks, of which at least seven courses are preserved, laid in a regular fashion (i.e. forming a vertical wall). Nothing points to a former presence of an inclined surface such as a staircase or a ramp. Several light walls connect the northern outer wall of the podium structure and the exterior wall of the palace. They likely served as supports. Further to the west, ramp WBN 167W is visible, clearly separated from the latter structure.<sup>62</sup> By the eastern exterior wall, rooms WBN 152–153 are well-visible. Walls forming other rooms further to the west can be identified. Notably, walls of room WBN 146 do not seem to be built of fired bricks as marked in Hinkel's plan,<sup>63</sup> at least in the upper part of the wall. This is in concord with Hinkel's note in one of his working variants of the plan.<sup>64</sup>

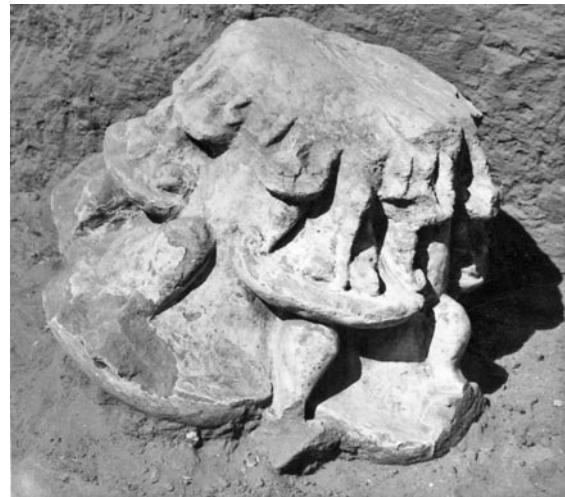
SAS.075

**SAS.075:** The photograph captures the second season in the course of excavations. A composite capital of capital type 2<sup>68</sup> is captured, fully unearthed. Based on information from Vercoutter's report,<sup>69</sup> the capital was found in room WBN 156, similar to capitals on photograph SAS.074.

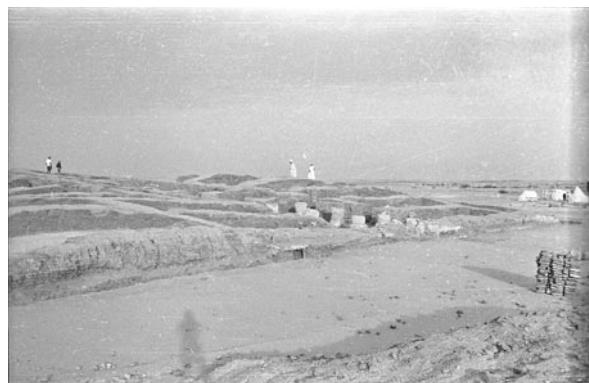
D-DAI-Z-Arch-FWH-F-KB-sw-075-08

**D-DAI-Z-Arch-FWH-F-KB-sw-075-08:** Nearly complete length of the southern exterior wall is captured on the photograph, as well as rooms of the southern part of the palace. In the foreground on the right, the southern spoil heap, a column of bricks, and sandstone architectural elements can be seen. Two archaeologists and two *raises* (?) can be noted in the background, on wall WBN 117/118 and WBN 140/142, respectively.

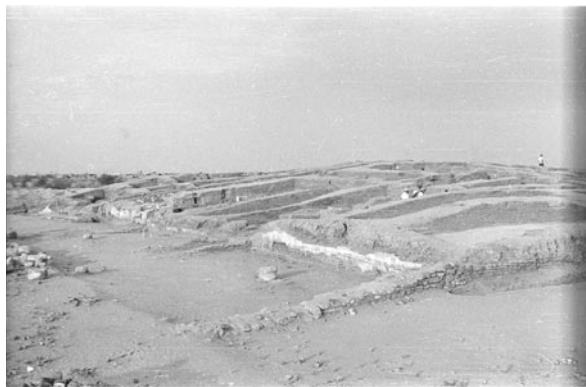
D-DAI-Z-Arch-FWH-F-KB-sw-075-09

**D-DAI-Z-Arch-FWH-F-KB-sw-075-09:** The south-western corner of the structure and nearly complete length of the western exterior wall are captured on the photograph. In the foreground, wall WBN 172 can be seen. On the left, sandstone architectural elements are deposited just behind the distinct limit of excavations. Thabit Hassan Thabit, Fritz Hintze, and two other persons can be noted in room WBN 103, another person walks in the background. Whitewashed plasters in rooms WBN 158 and WBN 160 can be seen. In the westernmost part of room WBN 106, unclear structural features seem preserved.

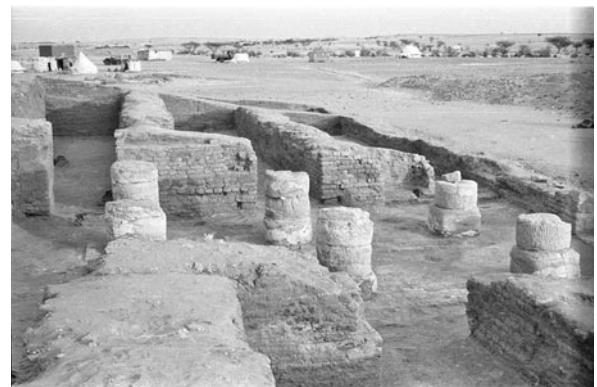
D-DAI-Z-Arch-FWH-F-KB-sw-075-10

**D-DAI-Z-Arch-FWH-F-KB-sw-075-10:** Rooms WBN 110 and WBN 154 can be seen in the foreground, the southern entrance is situated on the right. In the series of rooms WBN 134–136, there are several vessel emplacements, recorded also on photographs SAS.022, SAS.151, and SAS.153. A burnt wooden threshold can be noted in the entrance to room WBN 134, partly embedded in pockets in door jambs. In the background, the Small Temple, the dig house, and the camp can be seen.

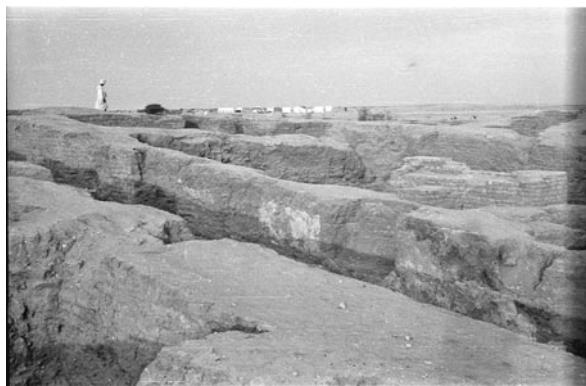
D-DAI-Z-Arch-FWH-F-KB-sw-075-11

**D-DAI-Z-Arch-FWH-F-KB-sw-075-11:** Room WBN 157 is captured in the centre of the photograph, with several cuts, possibly from burial pits, in its eastern wall. Remains of whitewashed plaster can be noted on it, particularly in its southern part. The slanting distribution of plaster recalls the situation in room WBN 160 as captured on photograph SAS.060. Besides, there seem to be also a slanting blackish spot, possibly from burnt wood deposited in a slope or a conflagration of a wooden construction. On the left, eastern wall of room WBN 113 is situated. Above room WBN 157, limits of rooms WBN 117, WBN 131, and WBN 156 are well-visible. On the top left, one of the *raises* (?) can be noted.

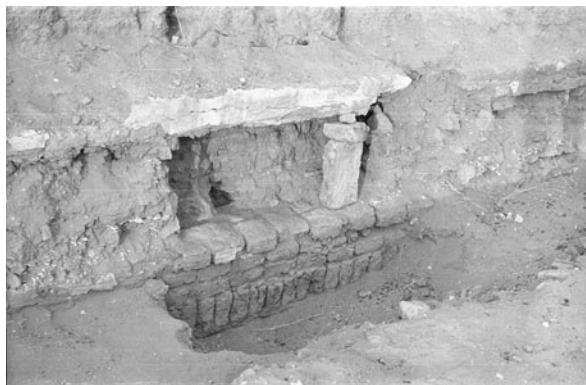
D-DAI-Z-Arch-FWH-F-KB-sw-075-13

**D-DAI-Z-Arch-FWH-F-KB-sw-075-13:** A section of the southern exterior wall is captured, a few meters to the west of the southern entrance.<sup>115</sup> A significant part of the wall face was apparently quarried away above the better-preserved, protruding foundation courses. In the lowermost one, bricks were laid as rowlocks.

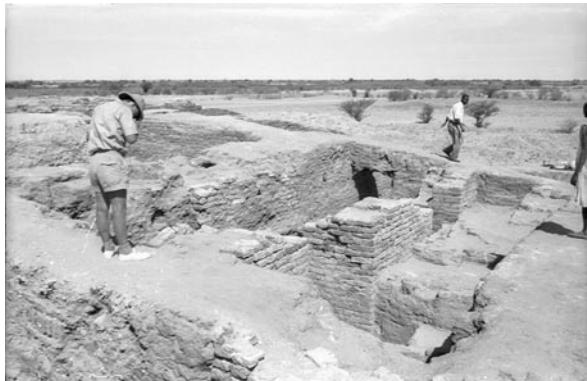
D-DAI-Z-Arch-FWH-F-KB-sw-084-13

**D-DAI-Z-Arch-FWH-F-KB-sw-084-13:** Room WBN 127 is captured in the centre, being photographed by a male archaeologist (Fritz Hintze?). The eastern part of the room is left un-excavated, as it apparently served to access the trench. The lintel over the entrance to room WBN 126, which was captured also by Shinnie from the other side<sup>117</sup> is well-preserved and a male archaeologist walks over it. The northern wall of room WBN 121 and the baulk excavated in trench T22<sup>118</sup> can be seen on the left. Fired brick (?) walls of the second storey (?) can be noted behind the photographing archaeologist. Western walls of rooms WBN 123–124 can also be seen, as can sandstone architectural fragments deposited to the north of the structure in the background.

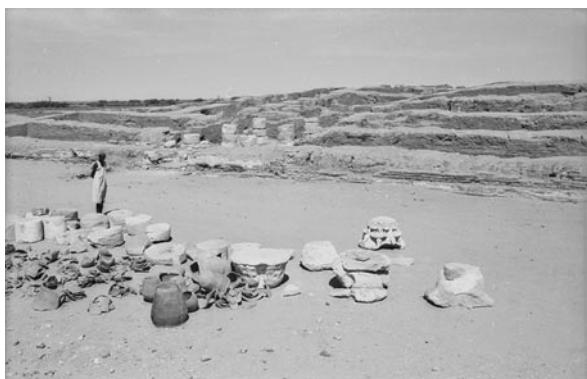
D-DAI-Z-Arch-FWH-F-KB-sw-084-17

**D-DAI-Z-Arch-FWH-F-KB-sw-084-17:** The photograph captures the southern exterior wall between rooms WBN 110 and WBN 136 and rooms further to the north. On the western wall of room WBN 157, remains of whitewashed plaster can be noted. In the foreground, stone architectural elements are deposited between the structure and the southern spoil heap, including column capitals of types 1–3.<sup>123</sup> Besides the capitals, there are also numerous potsherds, most likely grouped according to their origin from a single broken vessel. Some pottery forms can be clearly discerned: In the foreground on the right, a ledge-rimmed deep cylindrical vat (form B4b)<sup>124</sup> is deposited upside down, with its base missing. It may be the same vessel that was captured on photograph SAS.150, reused as an oven. Behind it, fragments of wheelmade spherical, ovoid, and cylindrical jars can be noted, some of fairly small proportions.

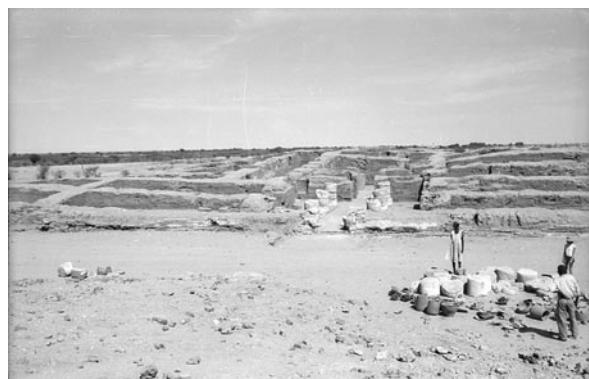
D-DAI-Z-Arch-FWH-F-KB-sw-084-18

**D-DAI-Z-Arch-FWH-F-KB-sw-084-18:** The photograph<sup>125</sup> captures the southern exterior wall between rooms WBN 101 and WBN 136 and rooms further to the north. On the western wall of room WBN 157, remains of whitewashed plaster can be noted. No remains of a ramp or other construction can be noted in the northern part of the room; the dent in the northern wall noted on photograph D-DAI-Z-Arch-FWH-F-KB-sw-075-15 is not paralleled on its left side. In the foreground, stone architectural elements, namely column drums, are deposited, as well as several groups of potsherds and complete or nearly complete vessels. Among the latter, a piece of a ledge-rimmed open conical vessel, possibly with a ring base (sub-form M8a)<sup>126</sup> can be noted next to two small-sized cylindrical jars or deep vats (*on the left*), a complete deep vat with plain rim (sub-form B4c)<sup>127</sup> is situated on the right, in front of the person in the foreground. Body of a spherical jar or the shoulder of an ovoid or cylindrical jar lies next to it; body of another is situated nearby.

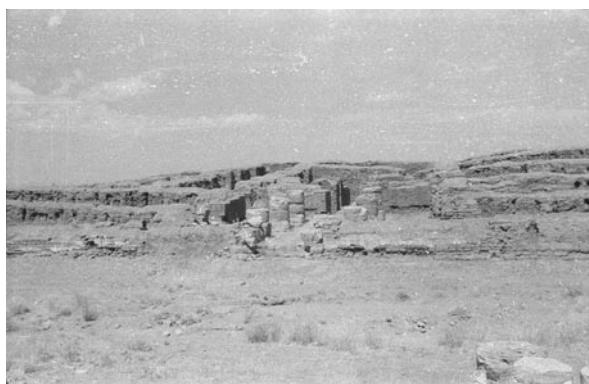
D-DAI-Z-Arch-FWH-F-KB-sw-110-51

**D-DAI-Z-Arch-FWH-F-KB-sw-110-51:** The photograph captures the entrance to room WBN 154 and the surrounding rooms. The bases of the northern walls of the room are washed away. Base of an ovoid jar (?) can be noted on the exterior wall to the left of the entrance.

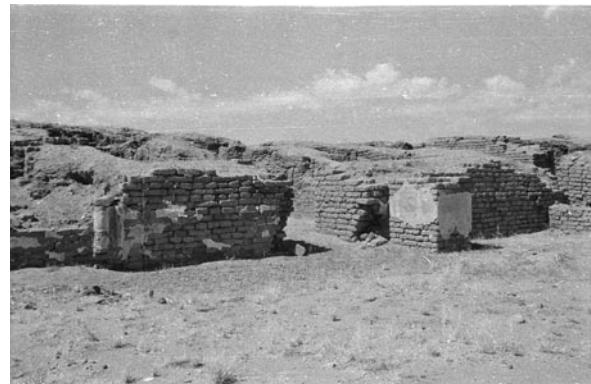
D-DAI-Z-Arch-FWH-F-KB-sw-110-53

**D-DAI-Z-Arch-FWH-F-KB-sw-110-53:** The photograph<sup>129</sup> captures the entrance to room WBN 142 and the well-preserved southern torus moulding on the façade of the eastern exterior wall. Two pillars abutting the wall and supporting the platform atop ramp WBN 161–162 can be noted on the right.

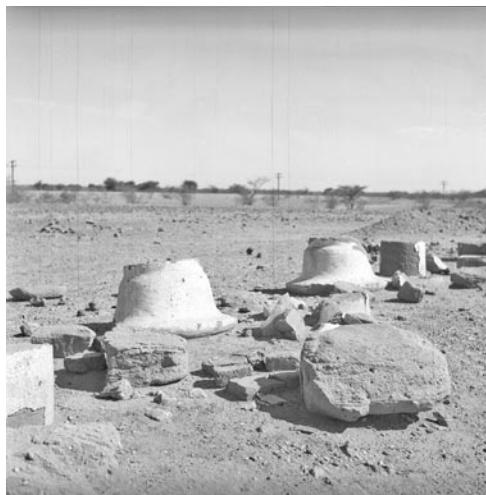
D-DAI-Z-Arch-FWH-F-MF-sw-R377-07

**D-DAI-Z-Arch-FWH-F-MF-sw-R377-7:** The photograph captures the southern exterior wall in the area of the entrance to room WBN 154. In the foreground, sandstone column drums are deposited, as well as several potsherds. Most of the pottery finds captured on photo D-DAI-Z-Arch-FWH-F-KB-sw-084-18 are missing.
